### VIBRATIONS AND INCLINATION SENSOR

- M18 housing
- AISI316L stainless steel housing (front included)
- IP67 protection degree

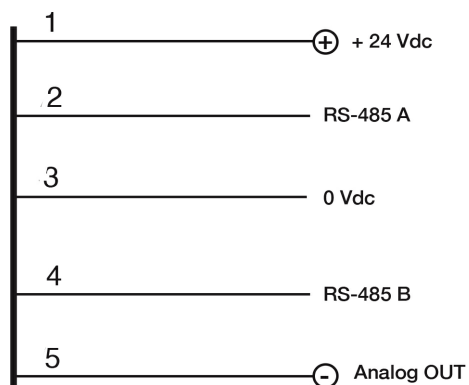
## ELECTRICAL DIAGRAMS OF THE CONNECTIONS

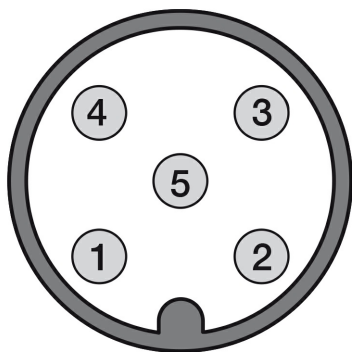
## CONNECTOR
